Hydrogeological Report,
4620 Eglinton Avenue West
and part 250 Wincott Drive,
City of Toronto

Project 15*4245 BRUCE A. BROWN ASSOCIATES LIMITED
CONSULTANTS IN THE ENVIRONMENTAL AND APPLIED EARTH SCIENCES

Re: Hydrogeological Report – 4620 Eglinton Avenue West
and part Richview Square, 250 Wincott Drive, Toronto

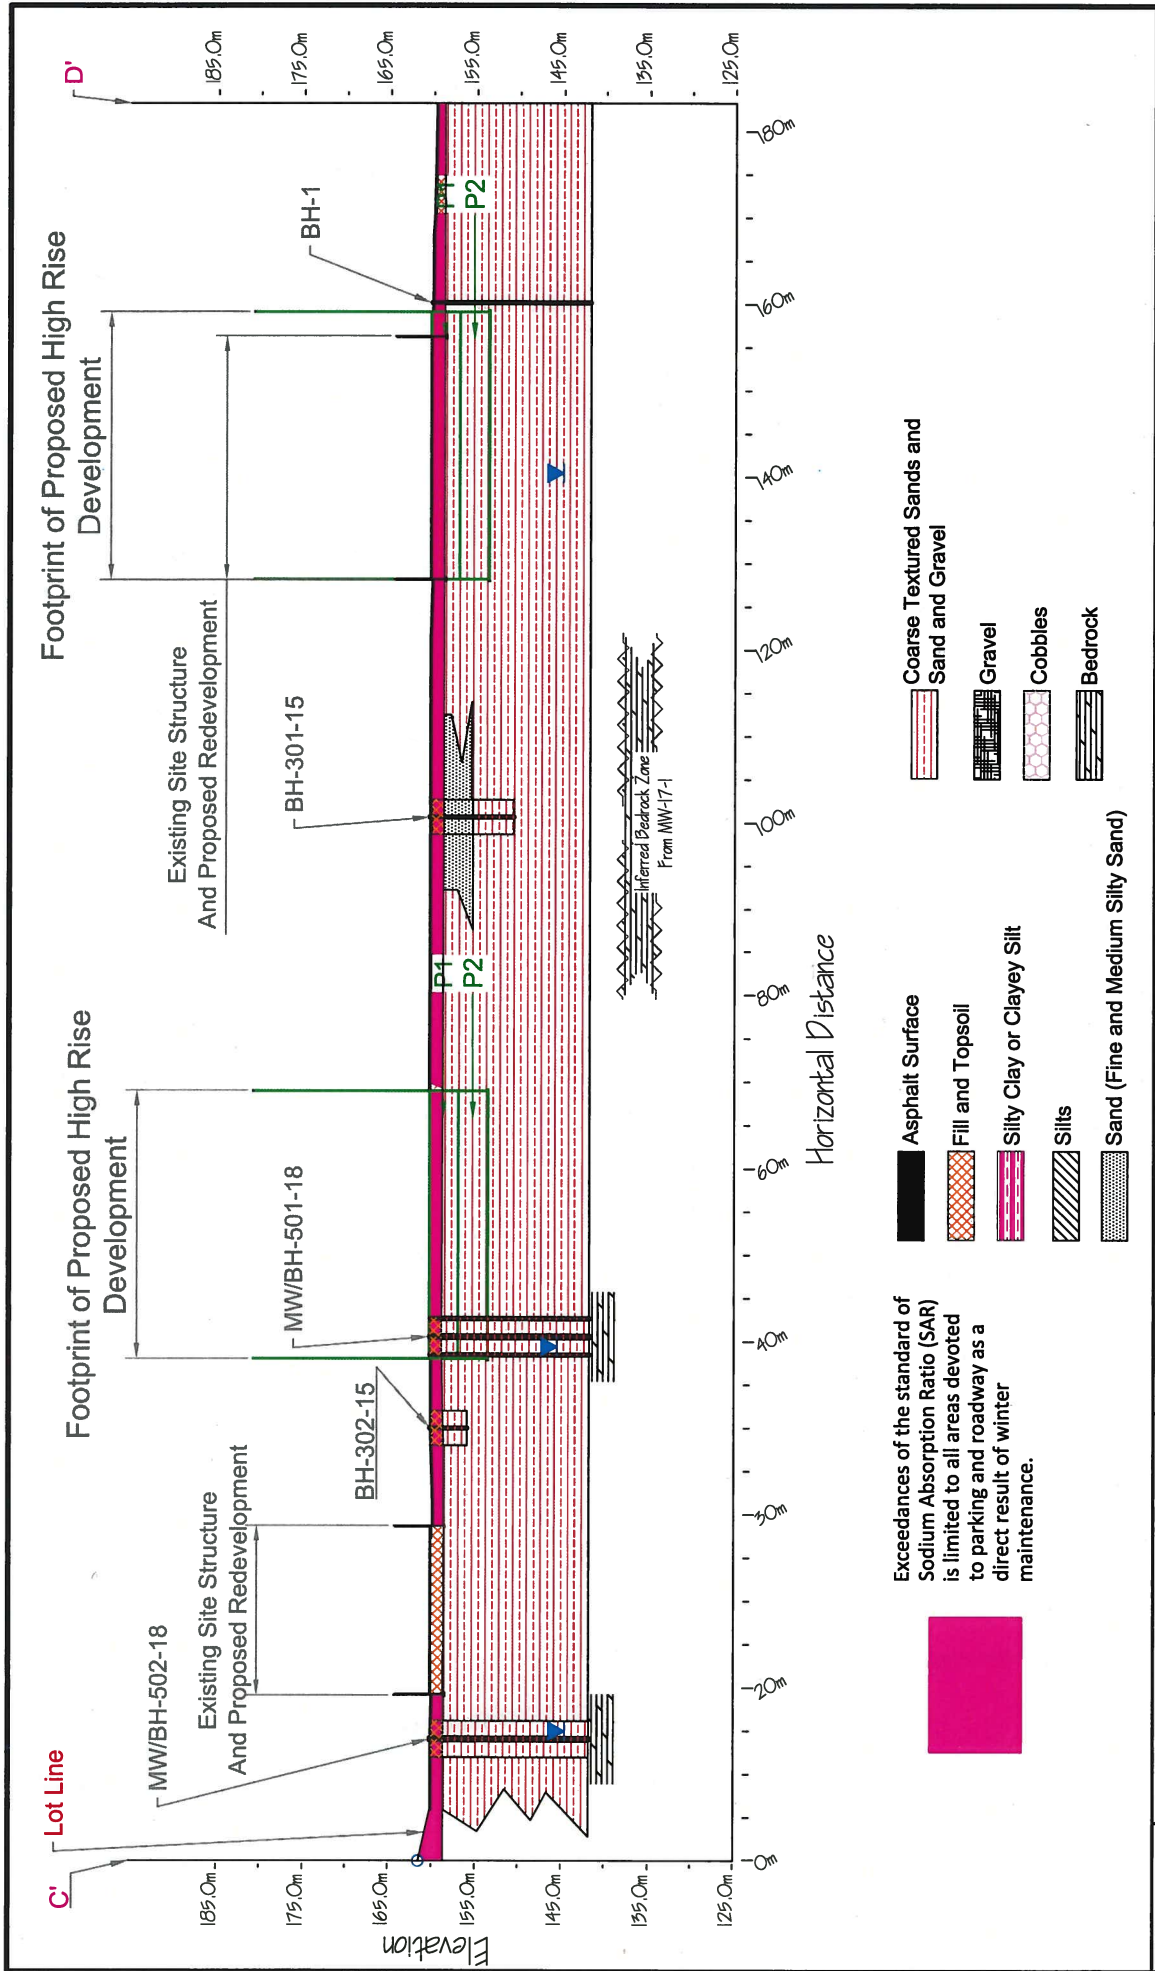
Figure: 3.3	Title: Cross Section C' to D' 4620 Eglinton Avenue West and Part of 250 Wincott Drive, City of Toronto	Client: Montrin Richview GP Inc., Suite 1000, 3250 Bloor Street West Toronto, ON, M8X 2X9	Drawn By: C. Colbourne, A.Sc.T. Project No.: 15*4245	Date: March 8, 2018 Drawing No.: 4245/80208-007/3
